Electric Corrosion due to the Discharge of Air Space between ADSS and Spiral Damper and the Solutions

Zhongtian Technologies Co., Ltd., Shanghai, PR China

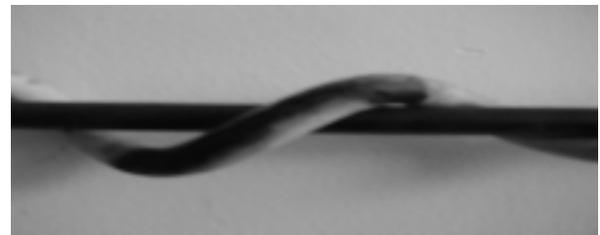
From table 2 we can see that after only 100 hours of test run, the tracking occurred on the damper's surface for the ADSS cable without the anti-corrosion paint or filling compound. After 600 hours of test run, severe erosions occurred on both damper and cable, as shown in figure 3.

Figure 3. Severe corrosion for the ADSS cable without the anti-corrosion paint or filling compound

1). The air space between ADSS and the gripping section of spiral vibration damper is filled up with the anti-corrosion paint. In this way, the electric corrosion resistance of both ADSS cables and dampers can be improved significantly. In the urgent case, the

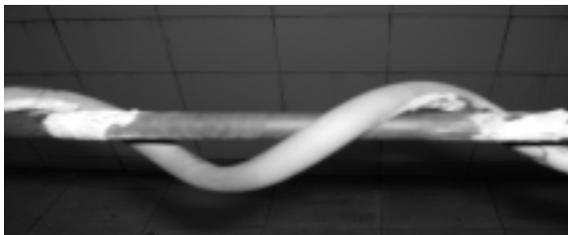
On the other hand, for the ADSS sections with the anti-corrosion paint (sample A) or filling compound (sample B), no erosion can be found even after 1000 hours of test run, as shown in figures 5 and 7, respectively. For sample A, there was still complete anti-

corrosion paint in air space between cable and the gripping section of damper after test. For the sample B, after test a part of filling compound was lost. For the purpose of the comparisons, sample A and sample B before tests are also shown in figures 4 and 6, respectively. The test results indicate that the ADSS cable with the anti-corrosion paint has a higher corrosion resistance and reliability.

Figure 5. Sample A after 1000 hours of test run

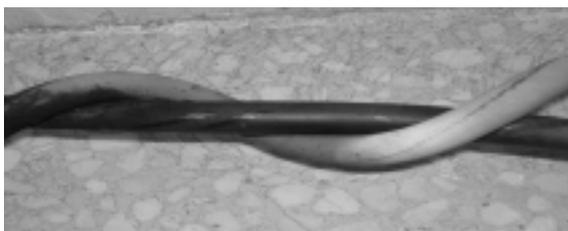
Figure 7. Sample B after 1000 hours of test run

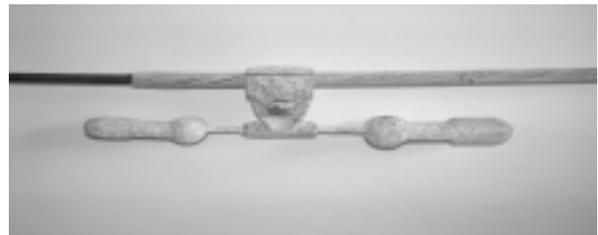
3). Lighter stockbridge damper: Instead of spiral vibration damper, the lighter stockbridge damper can be used for eliminating the air space discharge. Figure 8 shows test result for ADSS cable with the stockbridge damper after 1000 hours in a salt fog chamber.

Figure 8. Test result after 1000 hours in the salt fog chamber
